## The Time Capsules

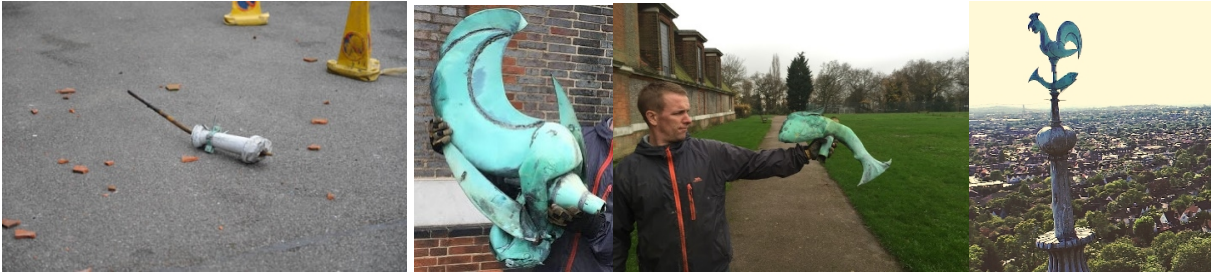
The story starts during the night of 17<sup>th</sup> & 18<sup>th</sup> November 2015 when Storm Barney struck North London and blew the weathervane out of the top of St Jude's spire. The 1 ¾ inch diameter wrought iron shaft on which the weathervane sat had been whittled away by the rain over the years to the equivalent of a sharp pencil point. Thus, when the weathervane jammed at some point during the storm, it simply snapped off and blew out of the spire. The shaft, encased in lead, cartwheeled down the spire, tearing the lead cladding, breaking the dressed stone cornice and destroying numerous roofing tiles before it hit the car park and fortunately, nobody was underneath when it fell as it weighed over 50kg. There is still a depression in the carpark where it hit the ground.

The Cock landed onto one of the dormers and the Fish on another from which they were rescued by St Jude's roofing contractors. Both the Cock and the Fish were badly damaged in the fall. The finial ball, which you can see in the right-hand picture remained at the top of the spire.

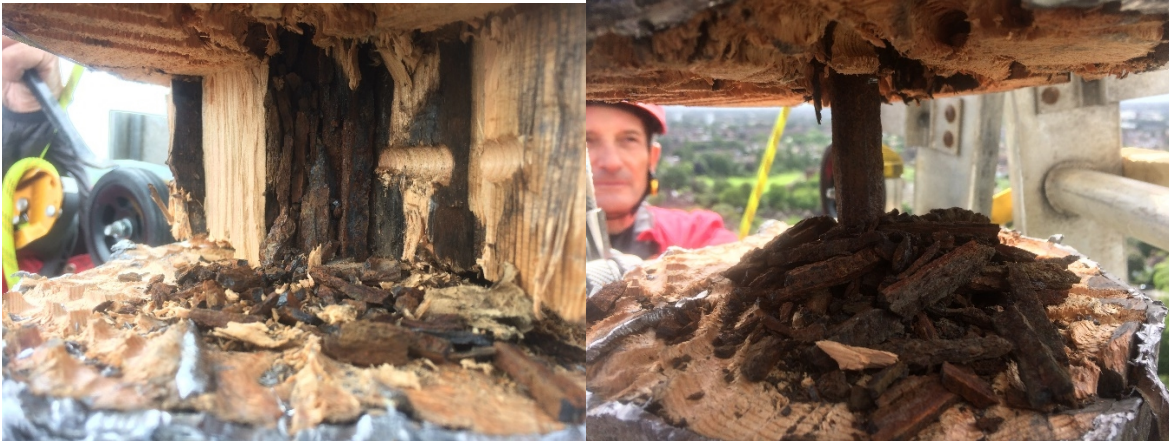
It was found that the original shaft was made of iron and the finial ball was made from bonded planks of pitch pine – an immensely durable timber similar to Douglas Fir. The finial ball covered in Code 12 lead was found to weight over 53kg. As a result, it took most of the day to remove the finial ball and the photos below give an indication of the scale of the problem:-
