The Time Capsules

The story starts during the night of 17th & 18th November 2015 when Storm Barney struck North London and blew the weathervane out of the top of St Jude's spire. The 1 ¾ inch diameter wrought iron shaft on which the weathervane sat had been whittled away by the rain over the years to the equivalent of a sharp pencil point. Thus, when the weathervane jammed at some point during the storm, it simply snapped off and blew out of the spire. The shaft, encased in lead, cartwheeled down the spire, tearing the lead cladding, breaking the dressed stone cornice and destroying numerous roofing tiles before it hit the car park and fortunately, nobody was underneath when it fell as it weighed over 50kg. There is still a depression in the carpark where it hit the ground.

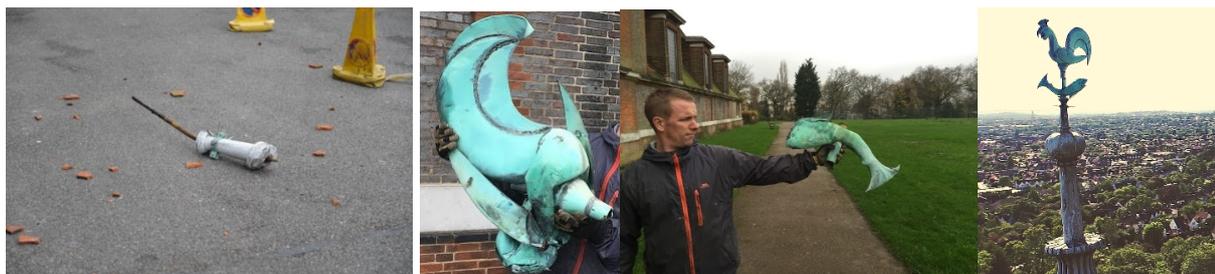
The Cock landed onto one of the dormers and the Fish on another from which they were rescued by St Jude's roofing contractors. Both the Cock and the Fish were badly damaged in the fall. The finial ball, which you can see in the right-hand picture remained at the top of the spire.

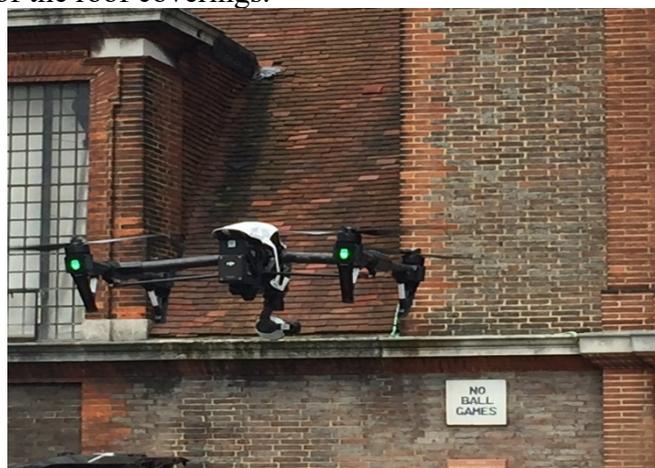
Initial investigations on site included the use of a drone-mounted camera to record the conditions at the top of the spire and of the roof coverings.

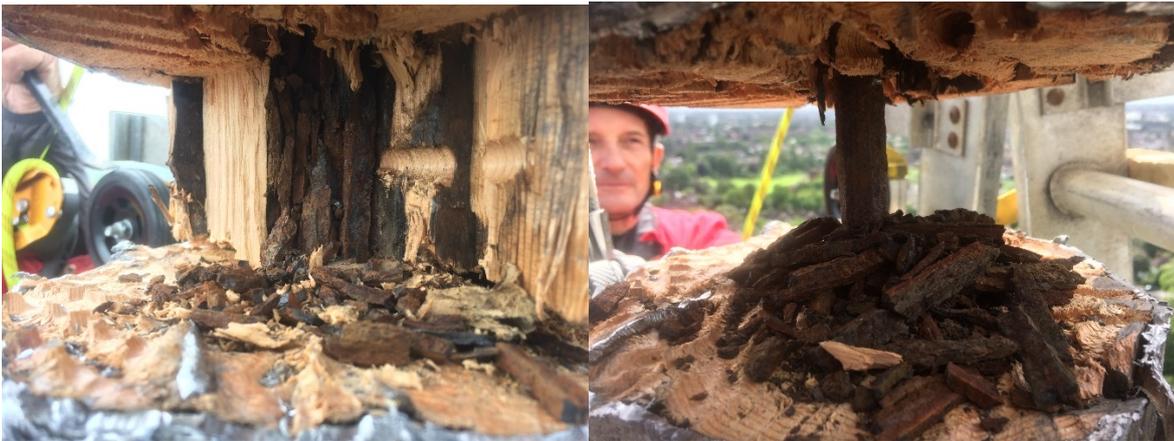
It was found that the original shaft was made of iron and the finial ball was made from bonded planks of pitch pine – an immensely durable timber similar to Douglas Fir. The finial ball covered in Code 12 lead was found to weight over 53kg. As a result, it took most of the day to remove the finial ball and the photos below give an indication of the scale of the problem:-

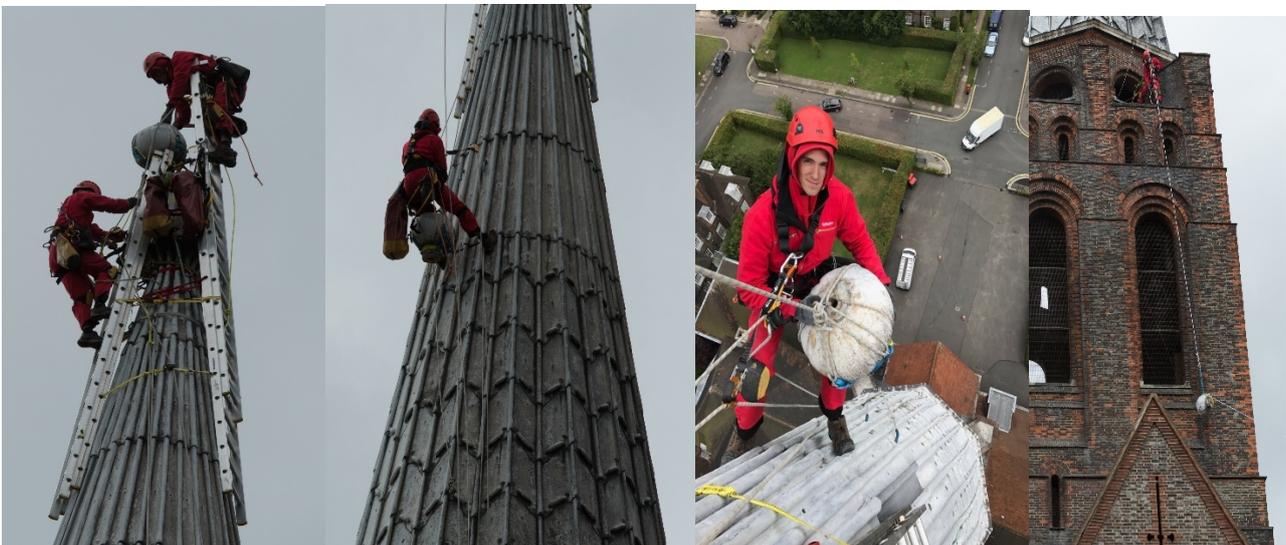
Removing the ball proved tricky and these photos shows the younger member of the team lifting the ball off the metal shaft and lowering it to the ground:-

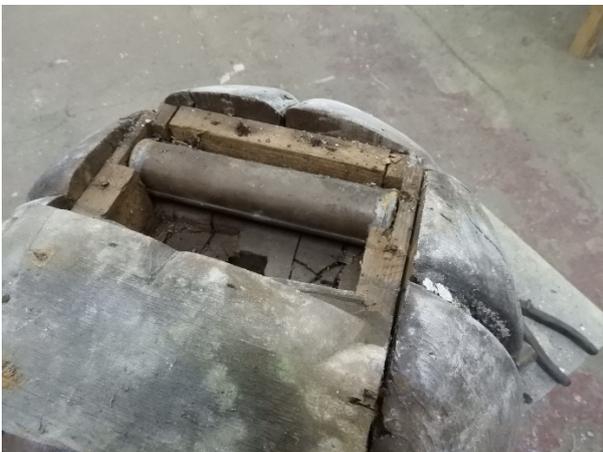
Residents were querying whether we had found a time capsule in the weathervane as Henrietta Barnett referred to it in her story of Hampstead Garden Suburb and in doing so, quoted from Samuel Barnett's text. It was only when the ball was delivered to a Conservator's workshop that we found that there were two such capsules inside the finial ball. One was the copper tube inserted into a socket cut into the finial ball and the other was an empty ¼ bottle of Bells Whisky which contained various documents, photos and business cards. The copper tube was the time capsule to which Henrietta had referred. The bottle was secreted into the finial ball before it was coated in lead. The picture below shows where they were found:-

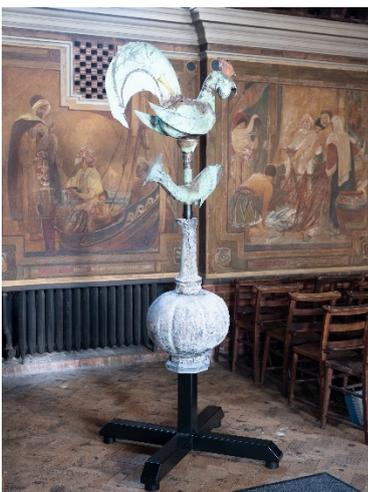
The original weathervane, part of the shaft and the original finial ball are all now mounted on a stand on display in St Jude's together with part of the shaft that has been removed from the top of the spire. Please feel free to have a look when the church is open.

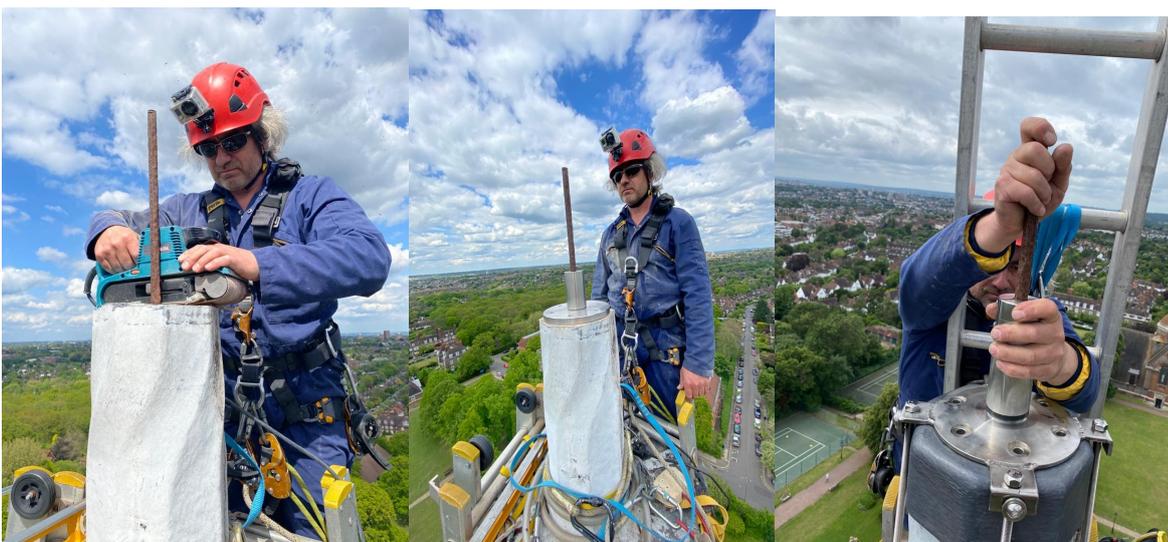
Before the finial ball and weathervane could be put up, new couplings had to be manufactured and given that the spire suffers from the worst the elements can throw at it, we decided that the most appropriate materials for the new coupling should be marine grade stainless steel to the specification required for offshore ocean racing. The next series of photos show Robin preparing and fixing the new connections:-

The flanges that have been added to the outer edges of the base serve two purposes, one to help anchor the base to the spire as you can see from the bolts and secondly, to provide connections for the lightning conductor.

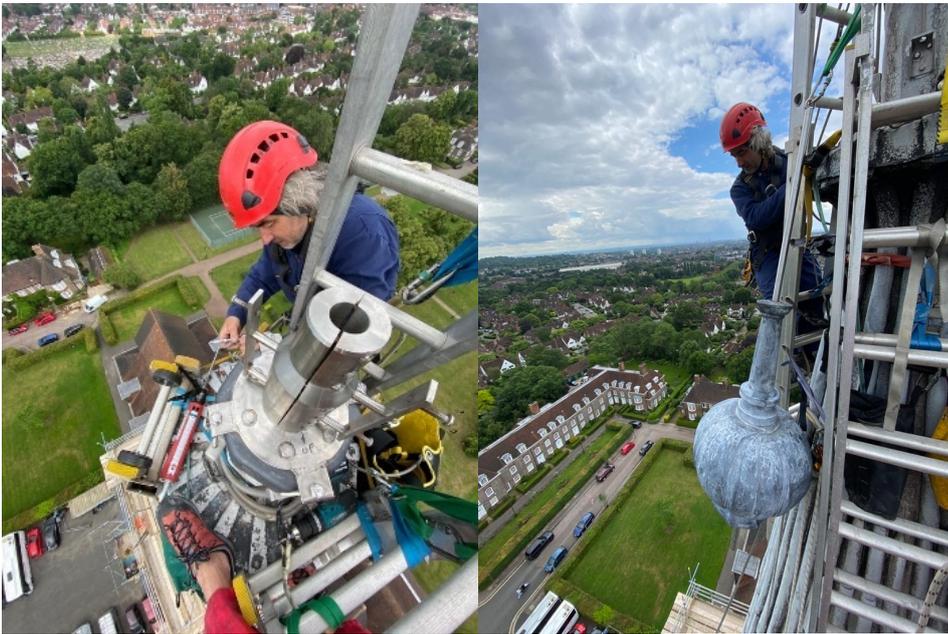
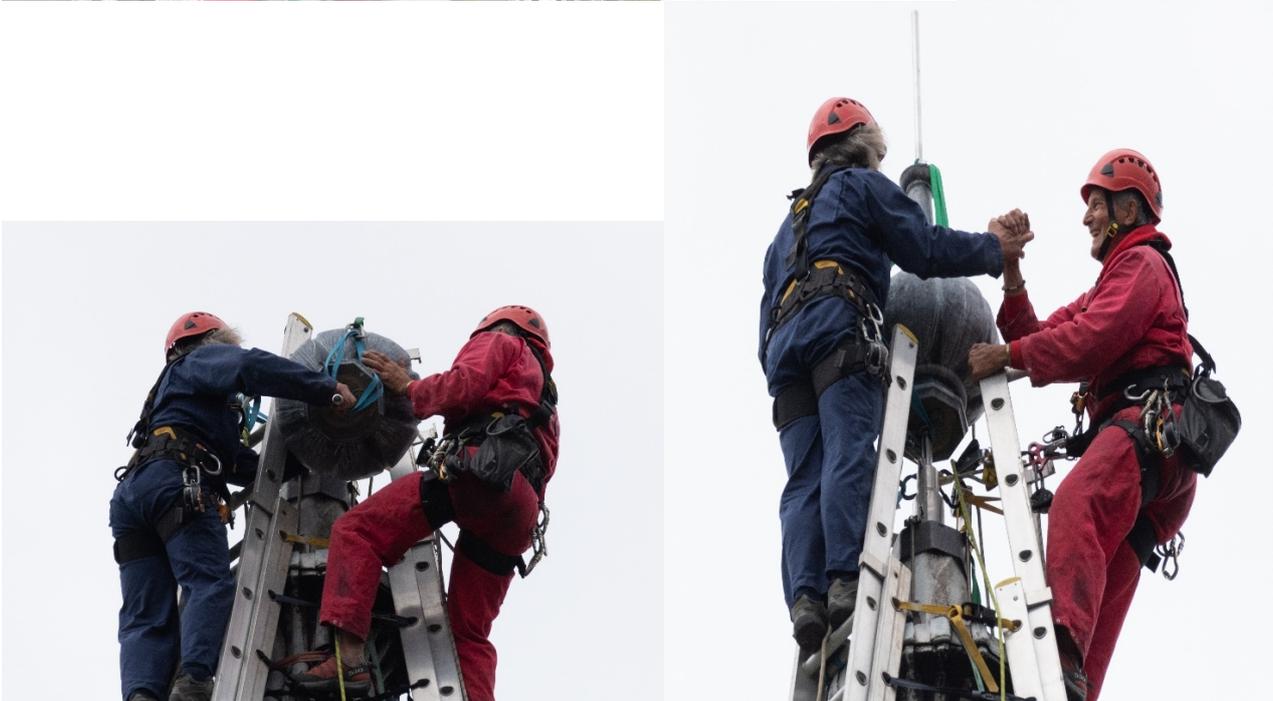
Once the base was in place, the new finial ball was hoisted up the tower and the spire to the very top where it and the new top extension of the shaft were mounted into the fitting. Robin Sims & Chris Milford of Wall Walkers Ltd can be seen congratulating each other once it was in place.

The new time capsules and their contents are secreted inside the base of the new finial ball either side of the shaft. The caps have been sealed shut against the ingress of moisture.

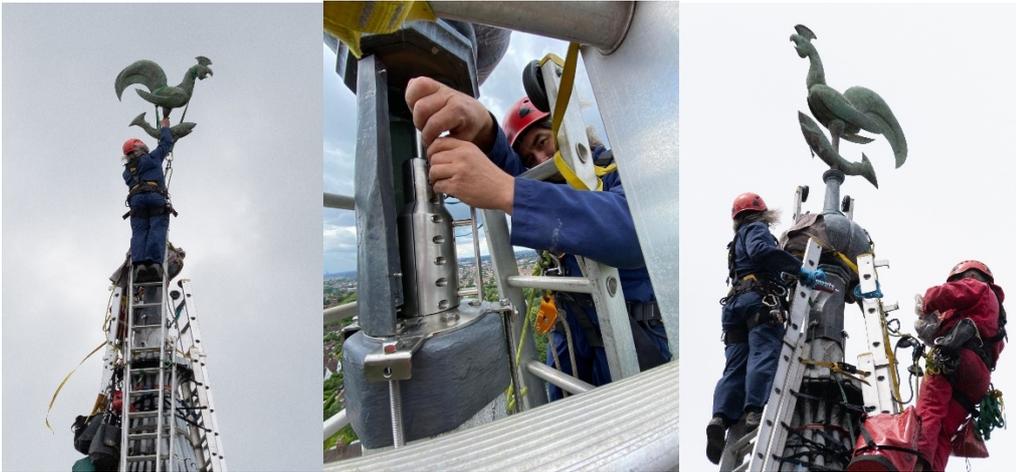
The new weathervane was blessed by the Reverend Alan Walker before being hoisted up the spire in its protective case. The ladders were raised to allow Robin and Chris to rise above the finial ball so that the new weathervane could be dropped onto the shaft as you can see below:-

The fish on the old weathervane was reputedly fixed on the north / south axis but we have since learned that it was moving as well. On the new weathervane both the fish and the cock are locked in the same plane to prevent vortexes building up between the two parts of the weathervane and thereby causing unnecessary stress. Consequently, for a rough guide to the wind direction, please take it for granted that St Jude's is built on an approximate east / west axis with the east of the building facing Southway. The car park is to the south of the church and central square to the north with the Church rooms being in the west.
