The Weathervane:

A Unique Opportunity for the Suburb:

6 LUTYENS' DESIGN OF THE BRICK TOWER UNDER THE SPIRE

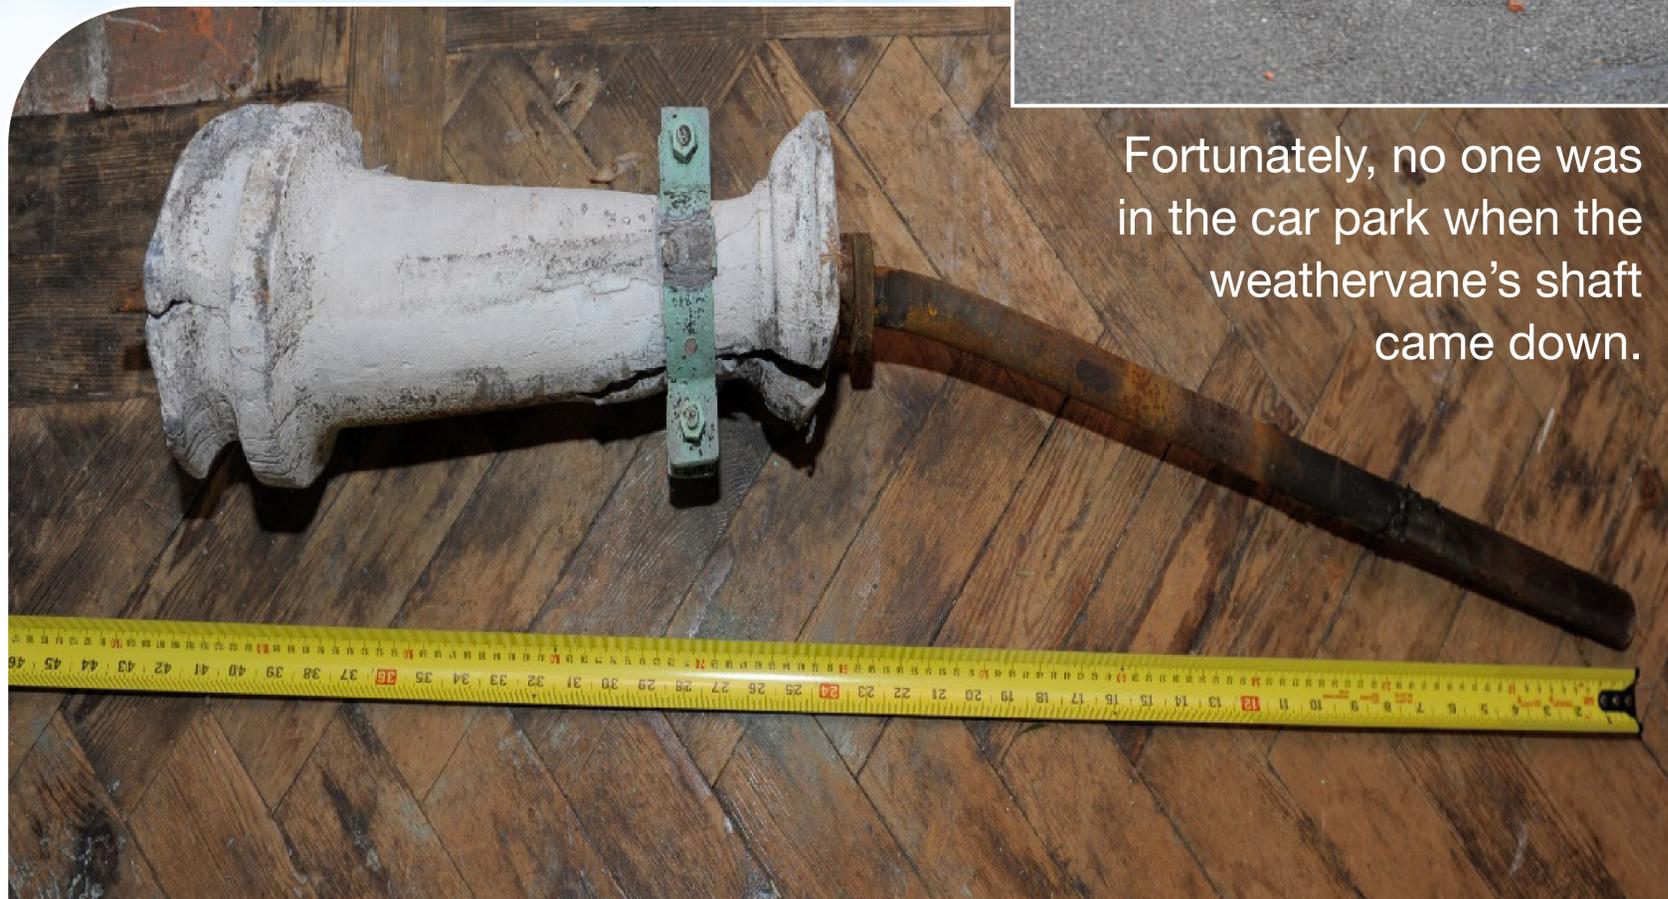
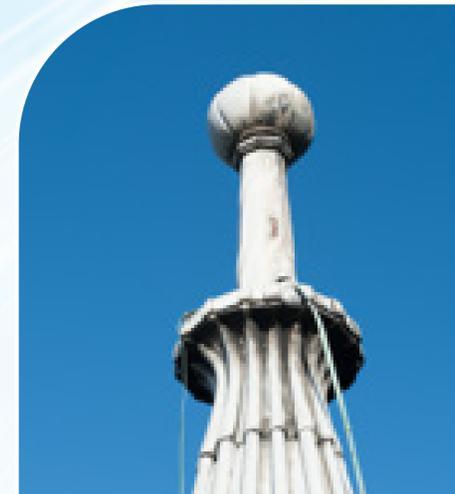
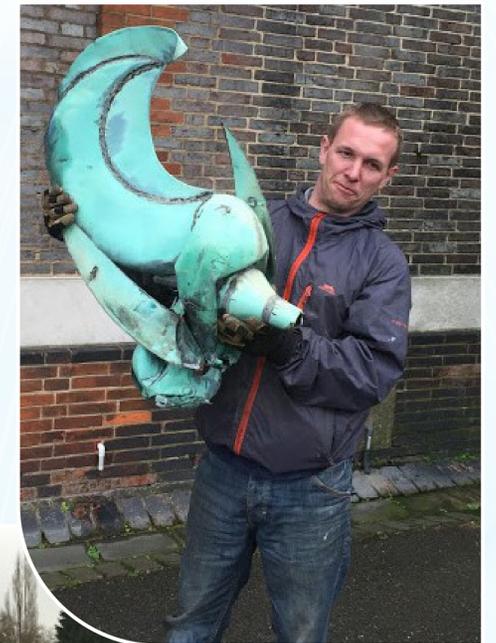
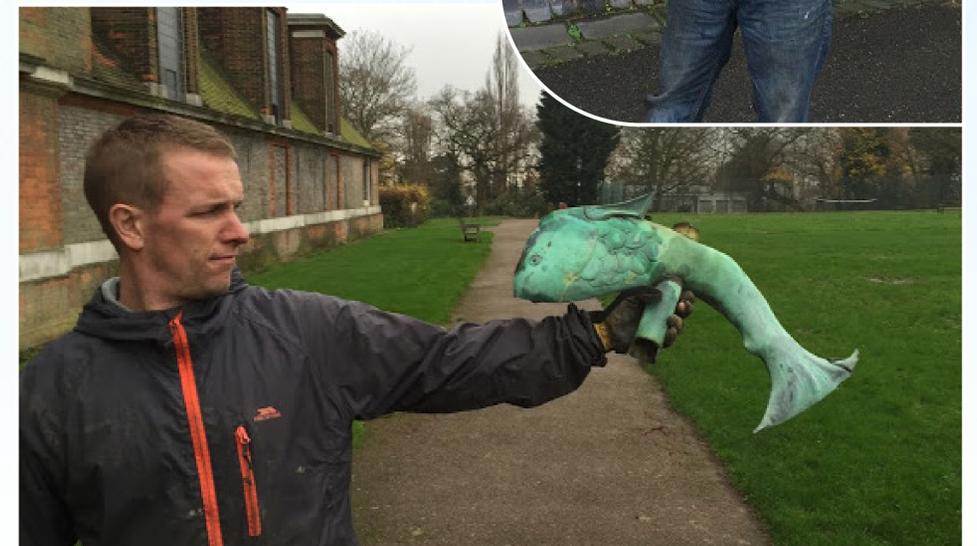
Fortunately, no one was in the car park when the weathervane's shaft came down.

The cockerel landed on one dormer and the fish on another leaving the spire a little bereft.

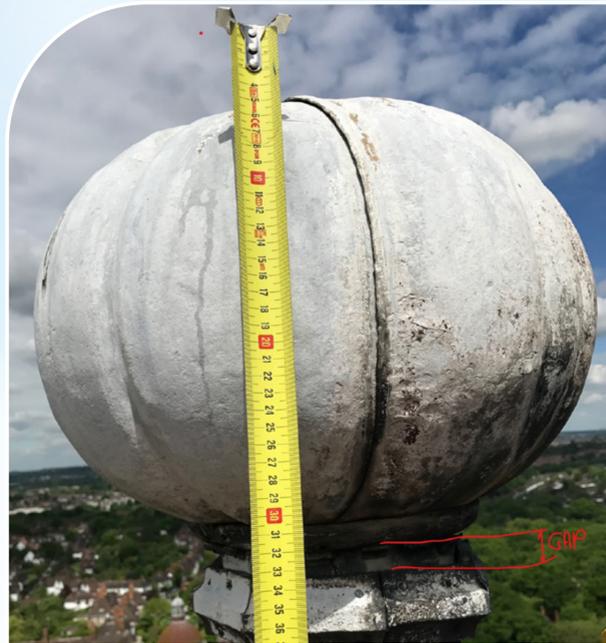
2 THE FINIAL BALL

This was a surprisingly large and heavy object. It weighed 53 kilos and was a solid lump of Douglas Fir, encased in lead and including two time capsules – see following images.

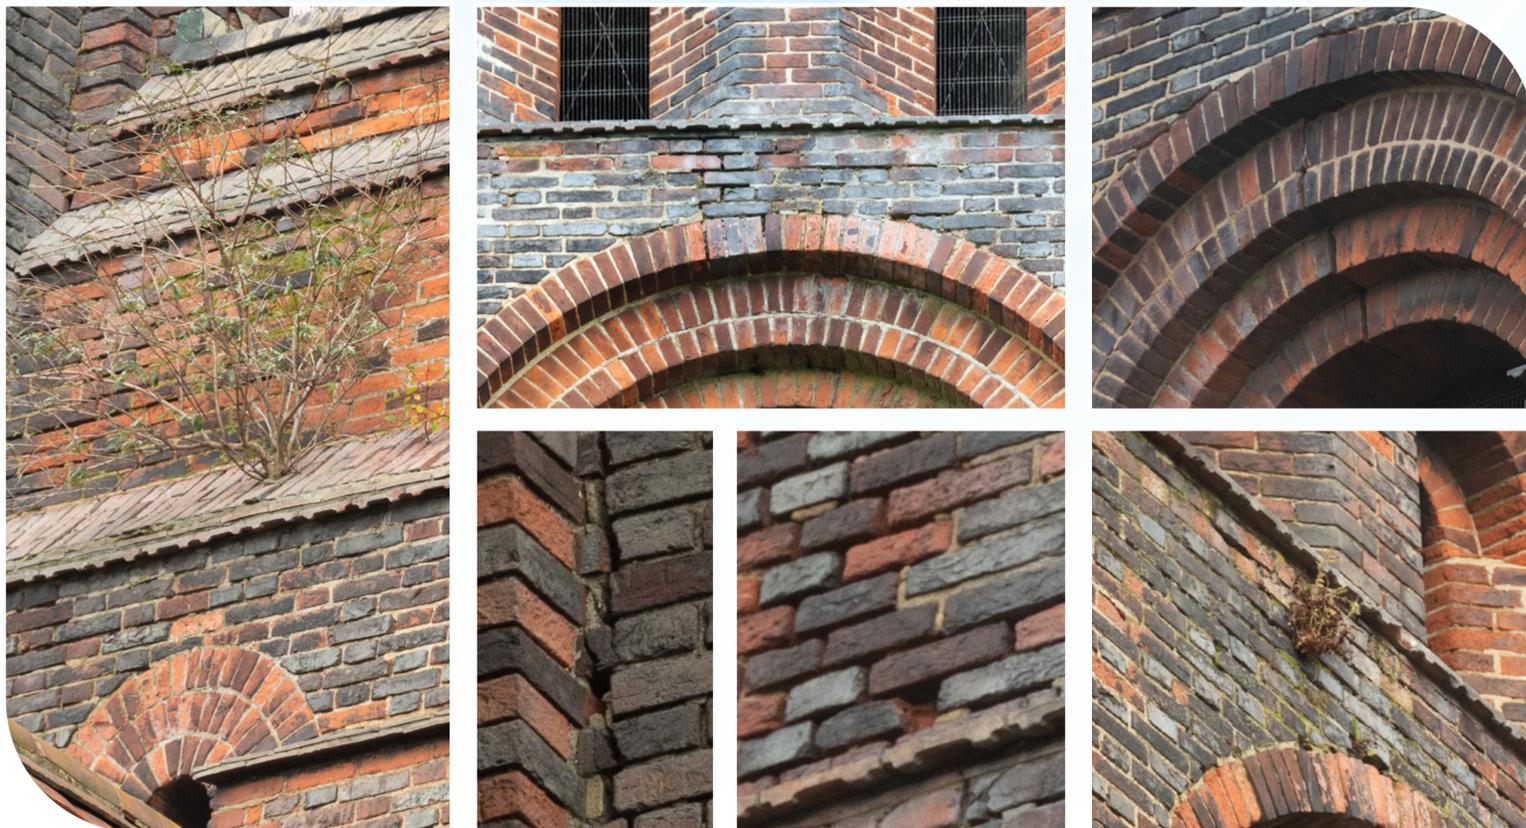
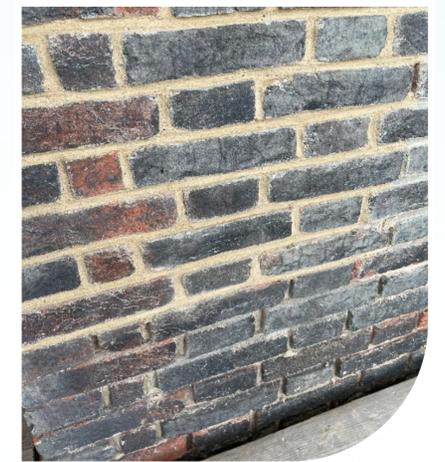
4 THE BRICKWORK ON LUTYENS' TOWER

Lutyens' tower sits at the highest point in Hampstead Garden Suburb and the tower is exposed to the worst that wind and rain can cause. The bricks were specially made; they are an unusual size. The original mortar dates from 1912 / 1913 and has been the subject of re-pointing works in 1949, some date unknown and 2016. These photos, taken from the ground, show their state before the scaffold was erected.

As the tower is Grade 1 listed, the pointing mix and technique must be approved beforehand by Historic England, to ensure it matches as closely as possible the appearance of the original. A lime mortar is used as this is breathable, allowing moisture to evaporate via the joints. If hard cement mortar were used, this could lead to frost damage, for example, when moisture trapped in brickwork freezes. The architect's recipe which has been approved is as follows: 3.5 Natural Hydraulic Lime with grey additive, Bath stone dust and a number 28 sand mix. All materials as supplied by the Cornish Lime Company. After initial cure the mortar is tamped back (NOT brushed back) with a natural bristle brush to ensure that there is a slight shadow line below the course above. The result can be seen in the image here:

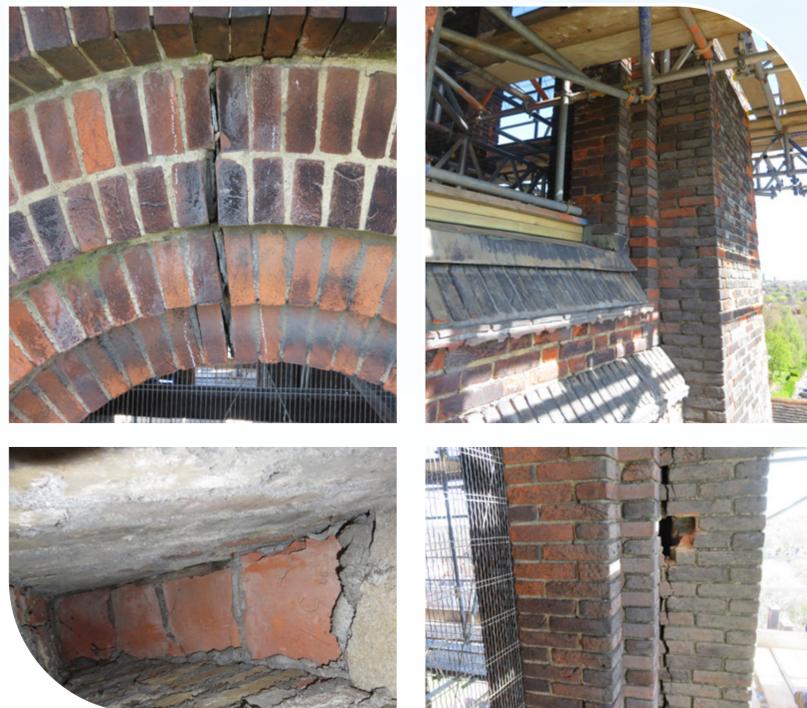
Once the scaffold was erected, a detailed inspection at close quarters could be undertaken and this is when and where the team, comprising the Project Architect, the Project Structural Engineer and the Site Manager (MCo Group), discovered we had a major problem.

Sir Edwin Lutyens had adopted a light-weight, 'thin wall, hollow-box' form of construction. It may be assumed that this form of construction was adopted to reduce the deadload of material upon the foundations, which are founded on clay. The removal of a fractured brick has enabled the Team to view the inside of the single-skin brickwork hollow box construction. There is no cross-bonding of brickwork, nor 'cross-ties', although a curious stone 'bridge' has been found. The returns at the sides of the hollow-box corners to the tower are constructed on stacked half bricks which are not bonded into the corner flanks. Whilst Lutyens' church is an architectural masterpiece, it is something of a miracle that this part of it is still standing! The lack of bonding means it is an inherently weak structure, highly vulnerable given its exposure to prevailing winds.

It is anticipated that it will be necessary to employ a combination of measures to stabilize and secure the brickwork as follows:

- The introduction of 9mm thick stainless steel stitches inserted to the returns of the corner columns at 350mm centres.
- The introduction of 'sock ties' across the centre/cavity.
- 'Dry fix' pointing to the sides of the brickwork columns between the windows.

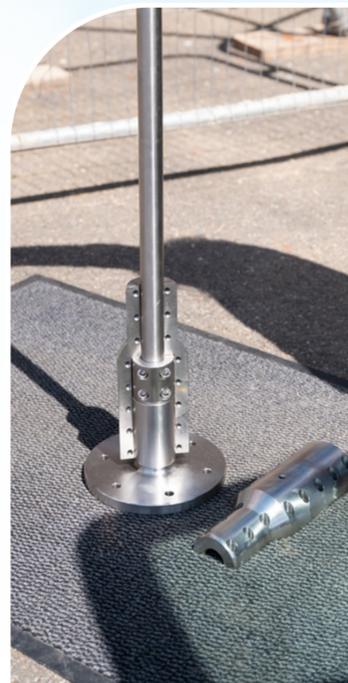
and here is its replacement:

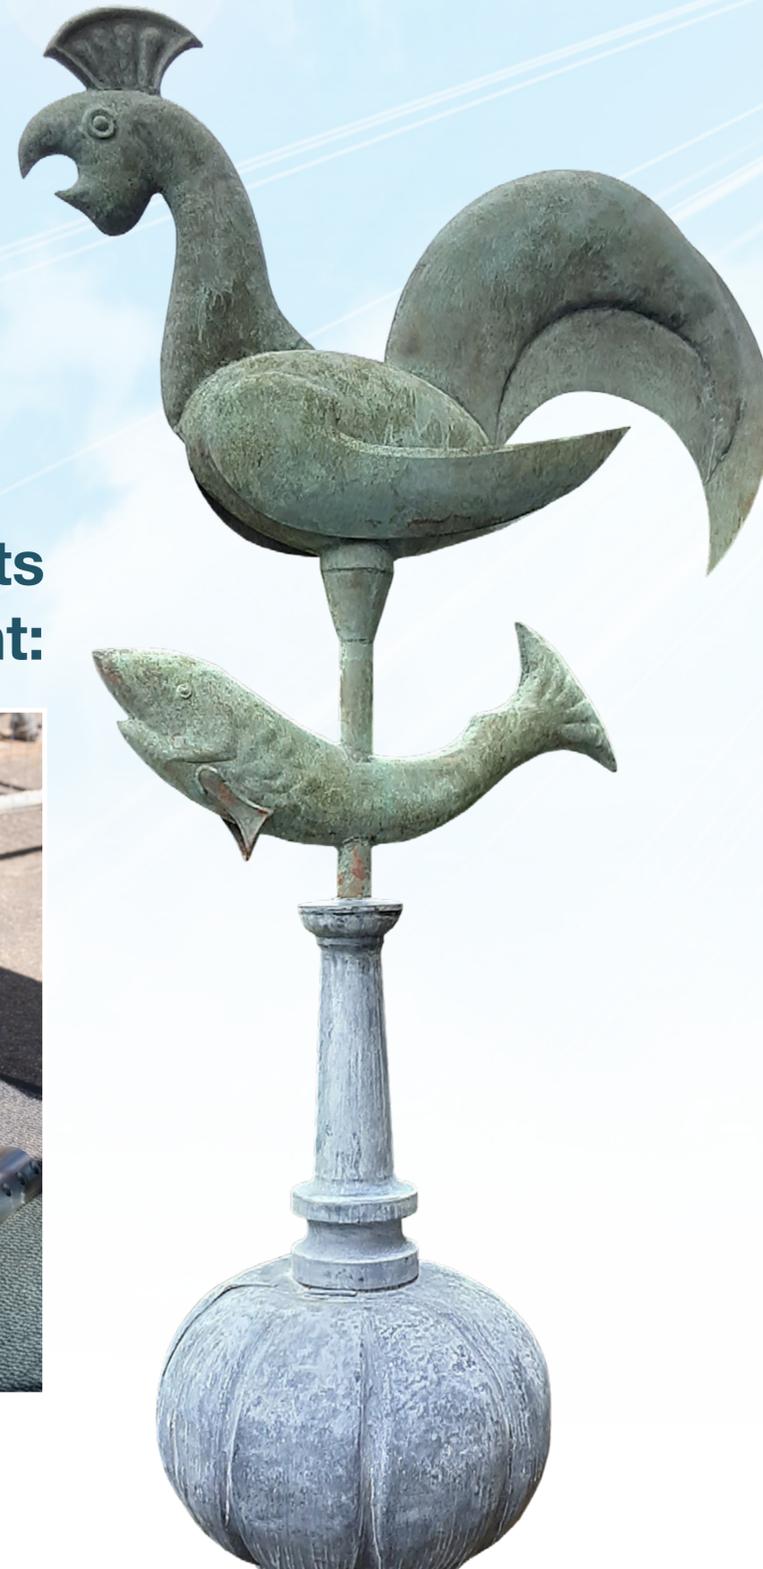
It will be mounted on a marine grade stainless steel base as shown here:
