## The Time Capsules

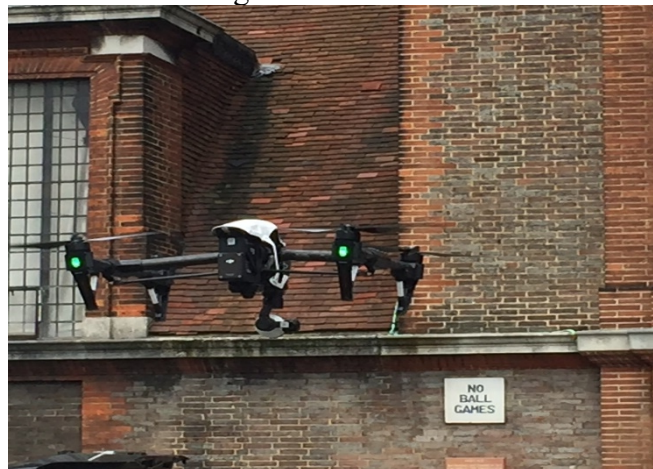
Initial investigations on site included the use of a drone-mounted camera to record the conditions at the top of the spire and of the roof coverings.

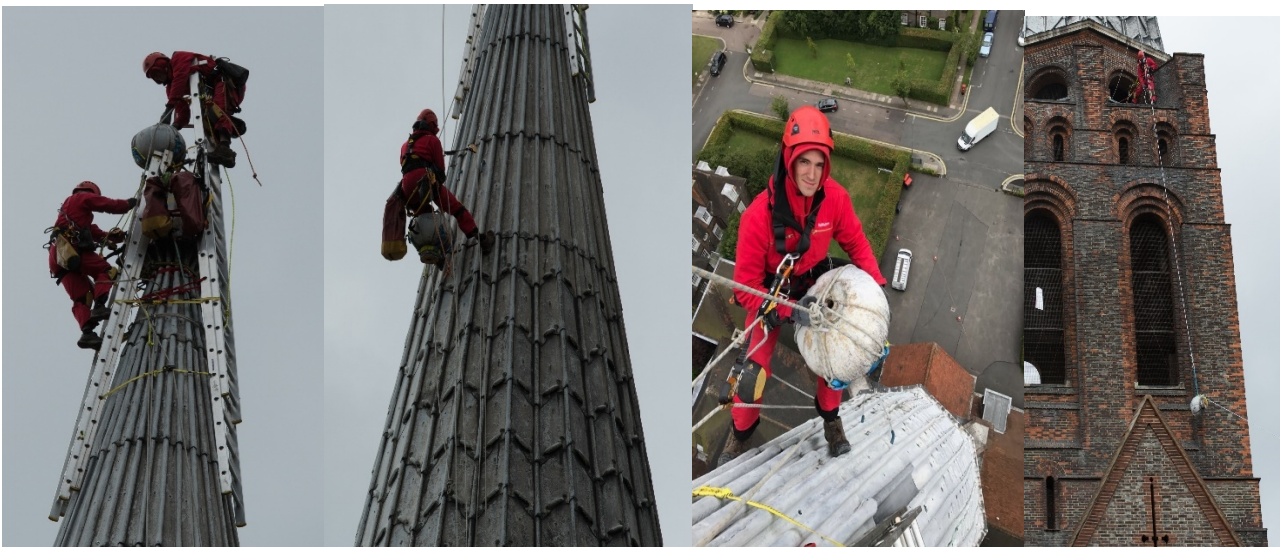
Removing the ball proved tricky and these photos shows the younger member of the team lifting the ball off the metal shaft and lowering it to the ground:-

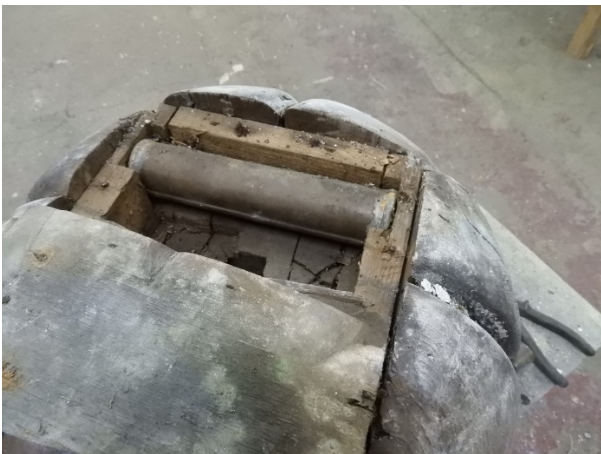
Residents were querying whether we had found a time capsule in the weathervane as Henrietta Barnett referred to it in her story of Hampstead Garden Suburb and in doing so, quoted from Samuel Barnett's text. It was only when the ball was delivered to a Conservator's workshop that we found that there were two such capsules inside the finial ball. One was the copper tube inserted into a socket cut into the finial ball and the other was an empty ¼ bottle of Bells Whisky which contained various documents, photos and business cards. The copper tube was the time capsule to which Henrietta had referred. The bottle was secreted into the finial ball before it was coated in lead. The picture below shows where they were found:-

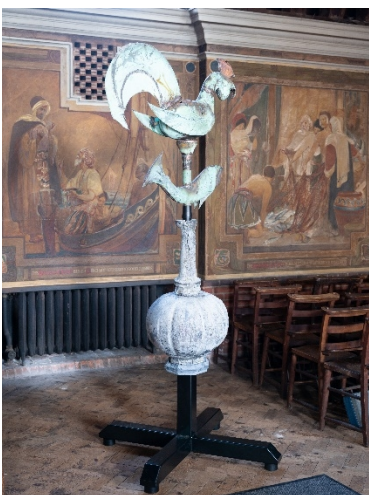
The original weathervane, part of the shaft and the original finial ball are all now mounted on a stand on display in St Jude's together with part of the shaft that has been removed from the top of the spire. Please feel free to have a look when the church is open.

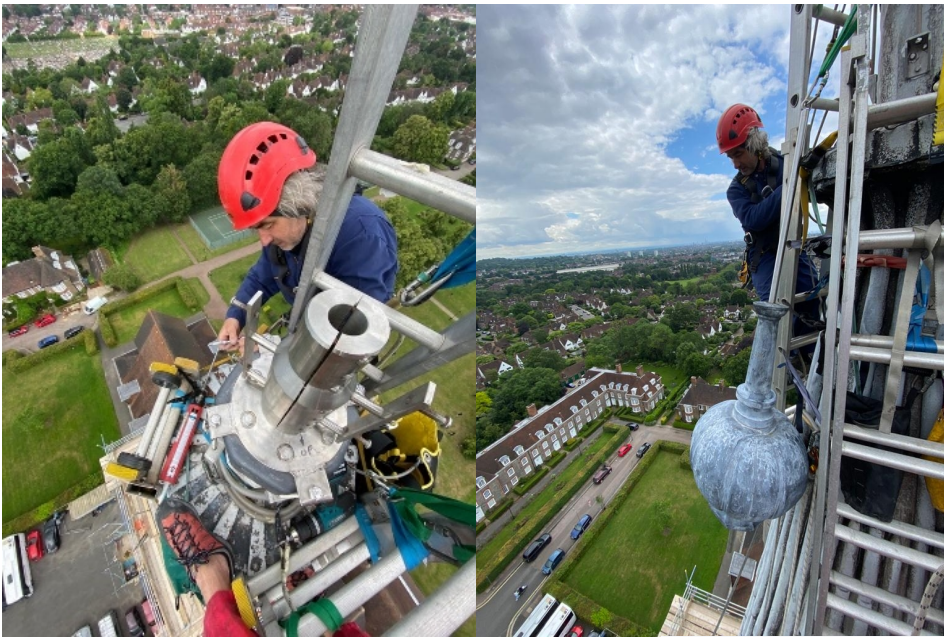
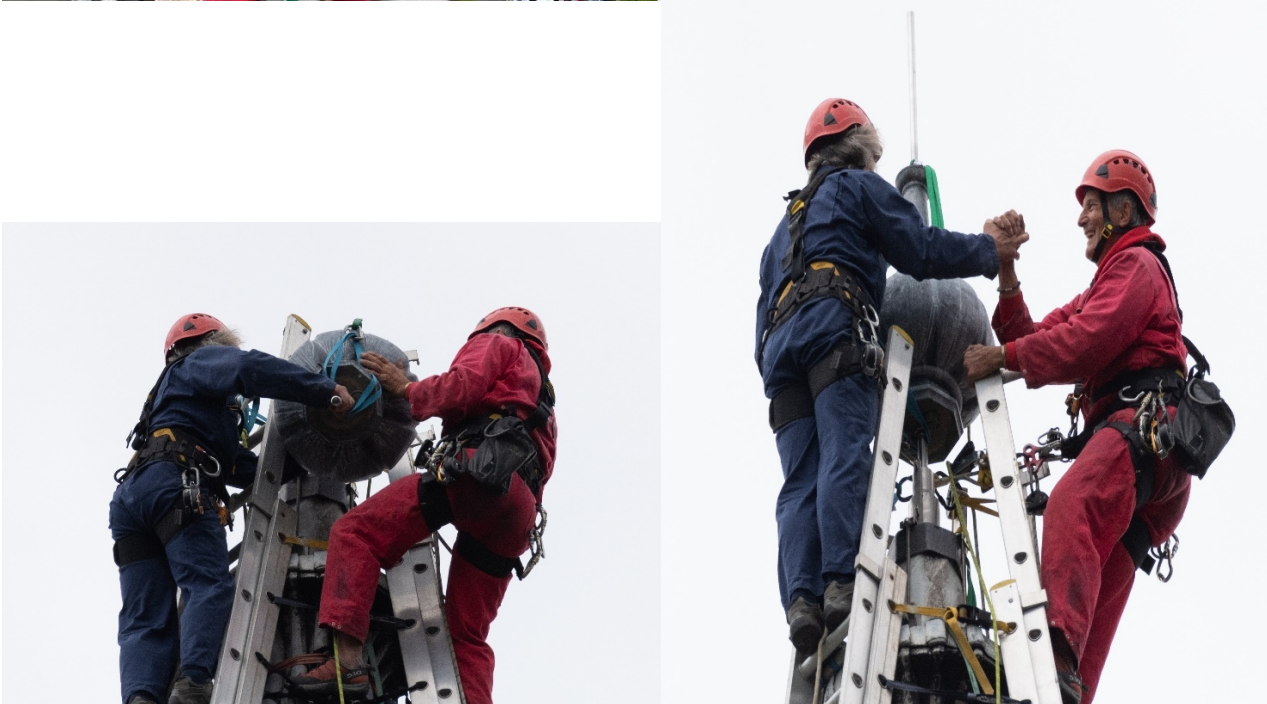
Once the base was in place, the new finial ball was hoisted up the tower and the spire to the very top where it and the new top extension of the shaft were mounted into the fitting. Robin Sims & Chris Milford of Wall Walkers Ltd can be seen congratulating each other once it was in place.

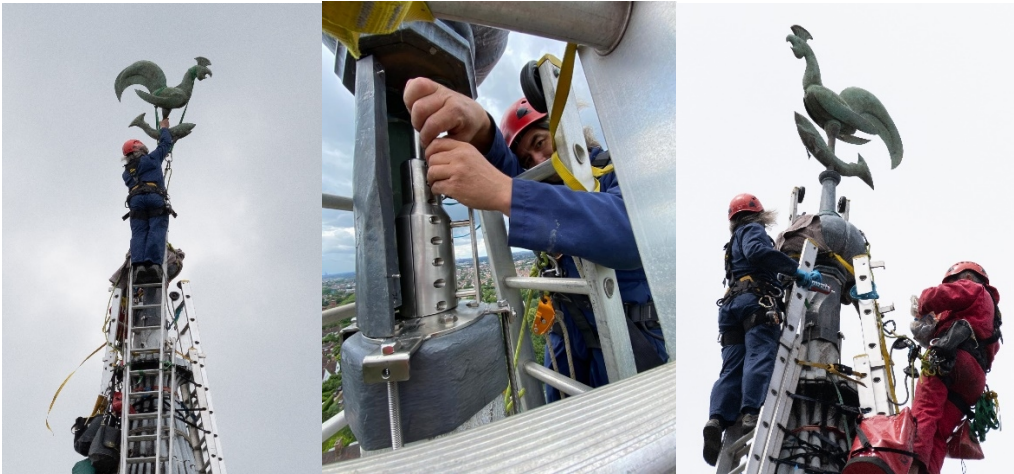
The new weathervane was blessed by the Reverend Alan Walker before being hoisted up the spire in its protective case. The ladders were raised to allow Robin and Chris to rise above the finial ball so that the new weathervane could be dropped onto the shaft as you can see below:-
